Hydrocarbon Track and Trace Project – Bellevue Light Industrial Area

September 2016

Bellevue Light Industrial Area Track and Trace Project

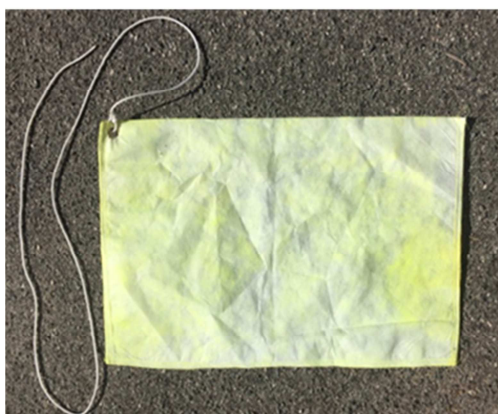
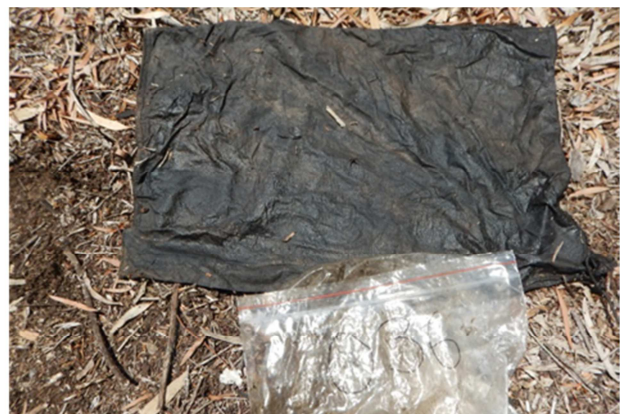
Figure 1 shows a clean MyCelx pad compared to a highly discoloured pad. This pad scored 100% for discolouration and was allocated a value of 3.

Figure 1: A clean pad (left) compared to a hydrocarbon affected pad (right)

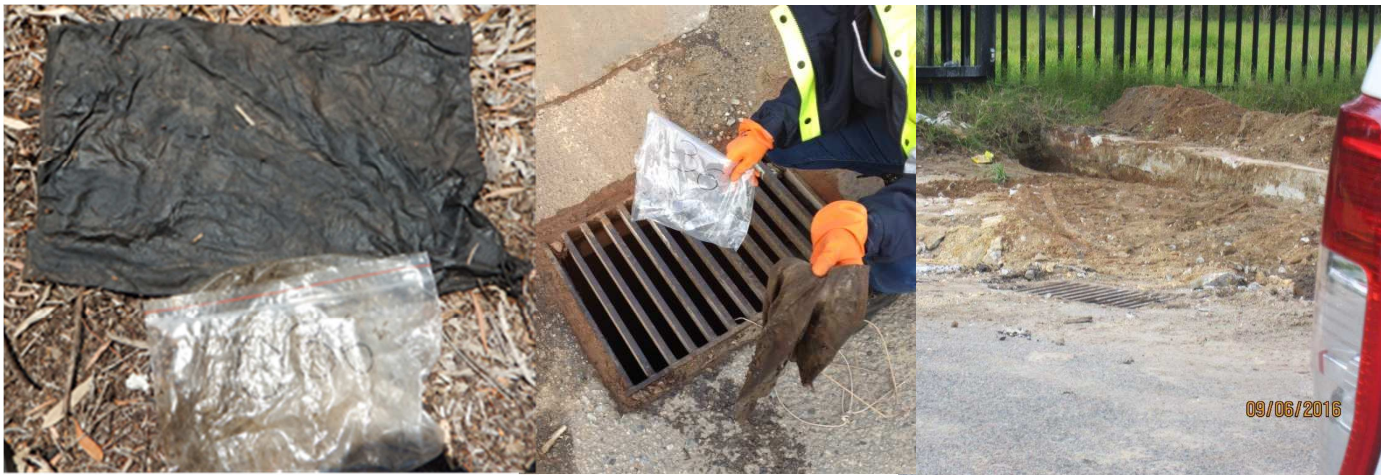
| | 9-Nov-15 | 6-May-16 | 10-Jun-16 | Water Quality Impact Priority |
|---|---|---|---|---|
| 1 | High – Strong petroleum odour and coated in thick oil | High – Strong petroleum odour and coated in thick oil | High – Strong petroleum odour and coated in thick oil | H |

Drain 1 located at the end of Oliver Street, Bellevue was the only sampling site where the MyCelx pads received 100% hydrocarbon coverage for each sampling event. Figure 5 highlights the amount of thick black oil adsorbed into the pad from the 9 November 2015 and 6 May 2016 sampling rounds. Although the site is in the middle of sub-catchment 1, there are only two drains on the same street upstream of the sampling site. This suggests that there may be a localised source of hydrocarbon pollution contaminating this drain. Further investigations should be undertaken as a high priority to identify the source of the hydrocarbon contamination.

Figure 5: Hydrocarbon pad collected from drain 1 at the end of Oliver Street November 2015, May 2016 and June 2016

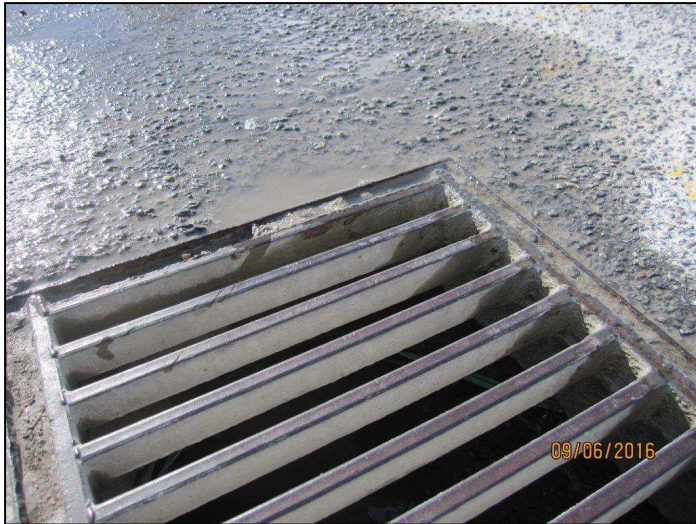
The photos below are an indication of impediments to collecting conclusive data. The cement has the potential to interfere with the adsorption of hydrocarbons onto the pads.

Photo 1: Cement running into Drain 3 on the corner of Wells and Irwin Streets (sub-catchment 4)

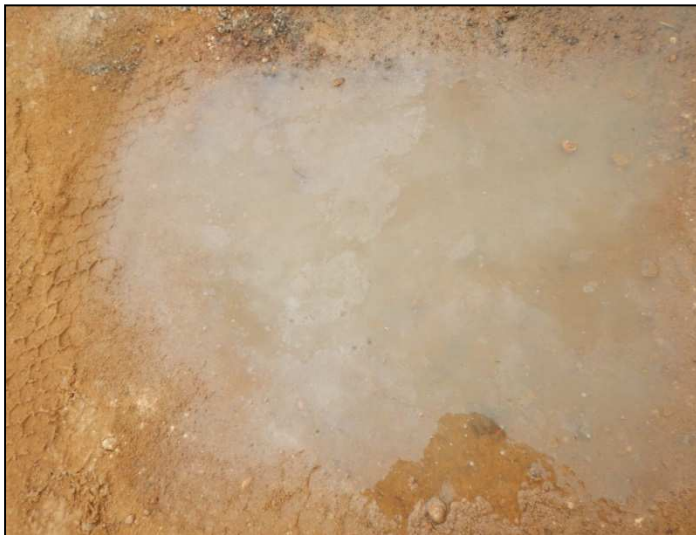
Photo 2: Hydrocarbon sheen in puddles near drain 22.

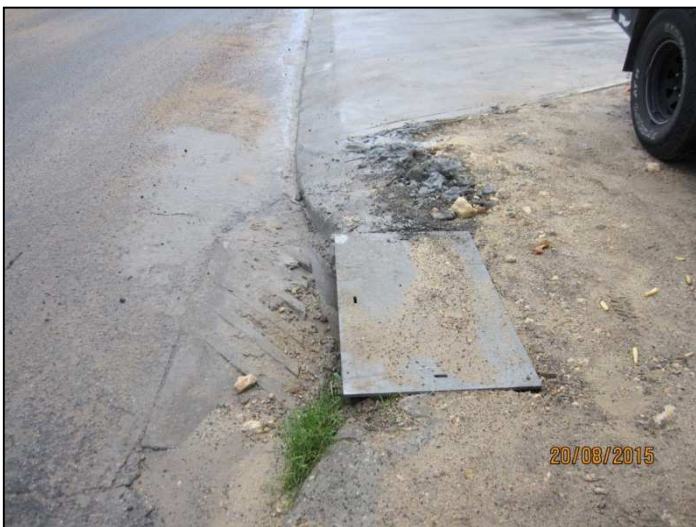
Photo 3: Site visit prior to sampling – cement and stone rubble around drain.
