Hydrocarbon Track and Trace Project – Bellevue Light Industrial Area

September 2016

Bellevue Light Industrial Area Track and Trace Project

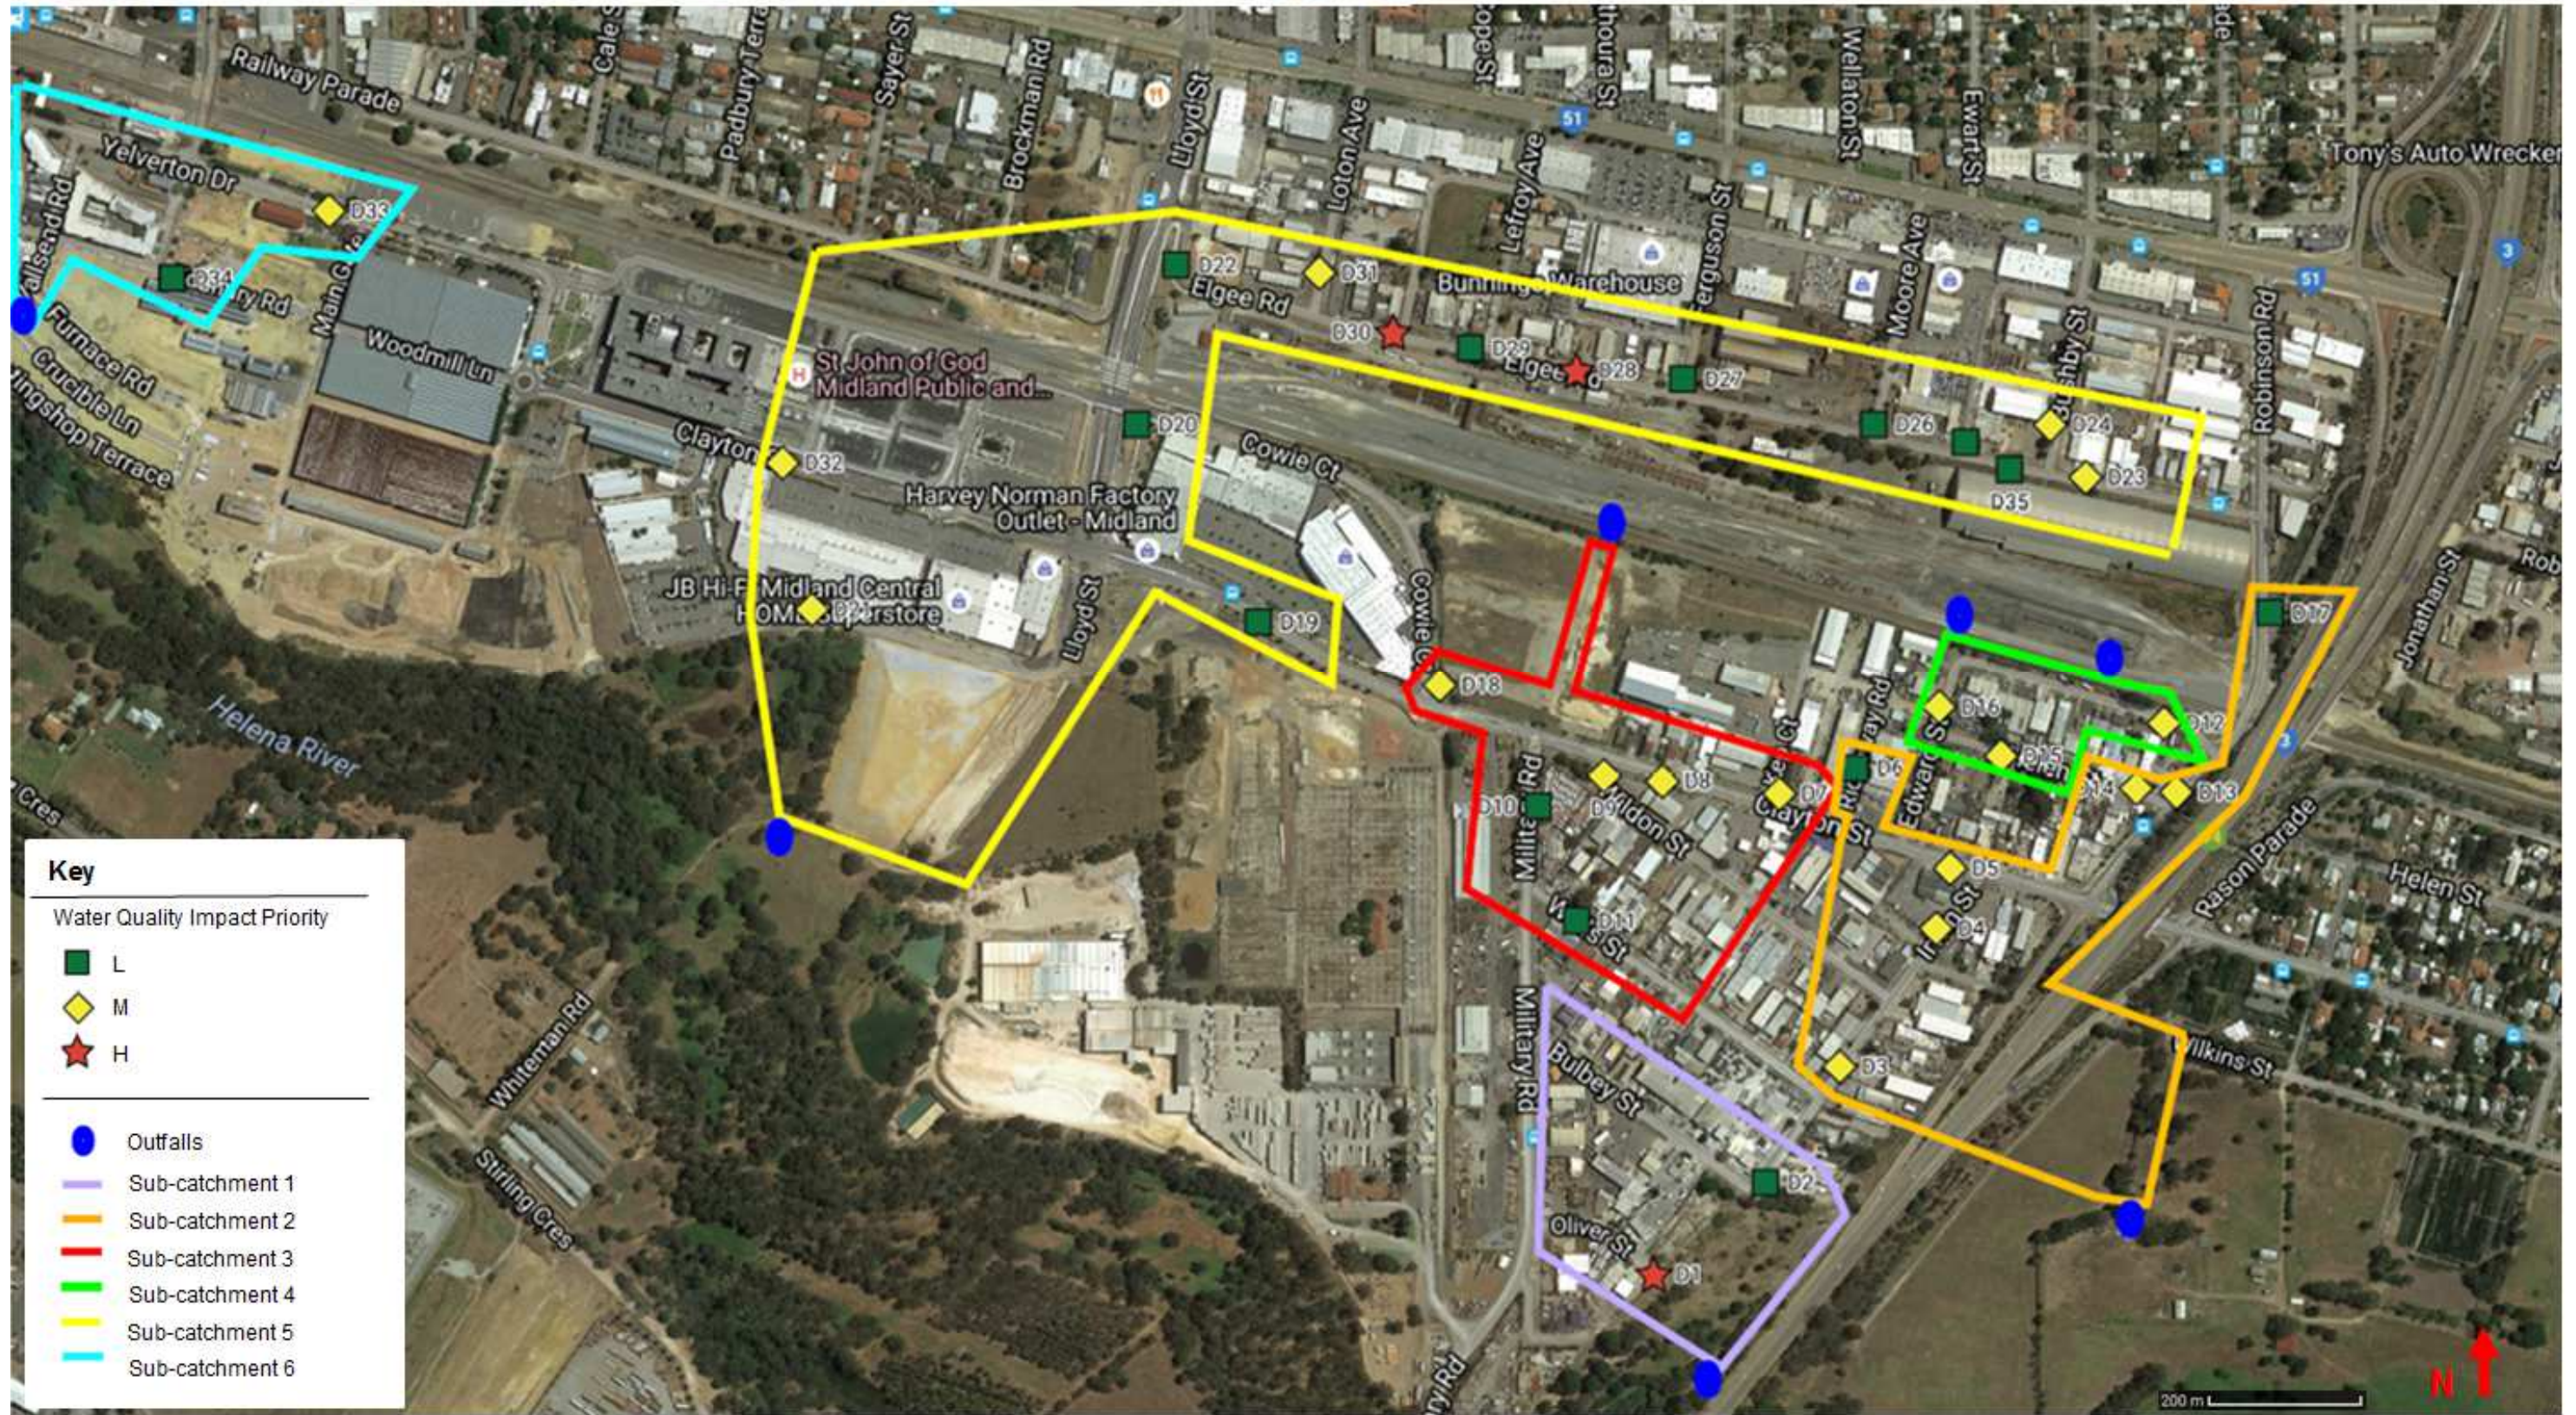
Figure 4: Drain site water quality impact priority and sub-catchments identified within the Bellevue light industrial area

From the City of Swan drainage information, 6 drainage sub-catchments were identified based on the stormwater discharge area (Figure 4). Not all sub-catchments drain into a drainage outlet into the Helena River, however, each sub-catchment was examined and analysed to determine and prioritise what action or investigation is required from the drain sites sampled.

Drains 12, 15 and 33 should also be prioritised as they consistently received medium readings for hydrocarbon across all three sampling events. These sites are also high in sub-catchments 4 and 6 so further efforts to investigate the sources of hydrocarbon can be targeted to a few streets in the area. Drain 12 receives flow from a small section of Rason Parade, drain 15 receives flow the middle of Helen Street while drain 33 receives flow from the eastern section of Yelverton Drive in Bellevue (Figure 4).
